## **Limited Visual Dam Safety Inspections**

**OA00021**

**Kemoo 5 Reservoir**

**May 2006**

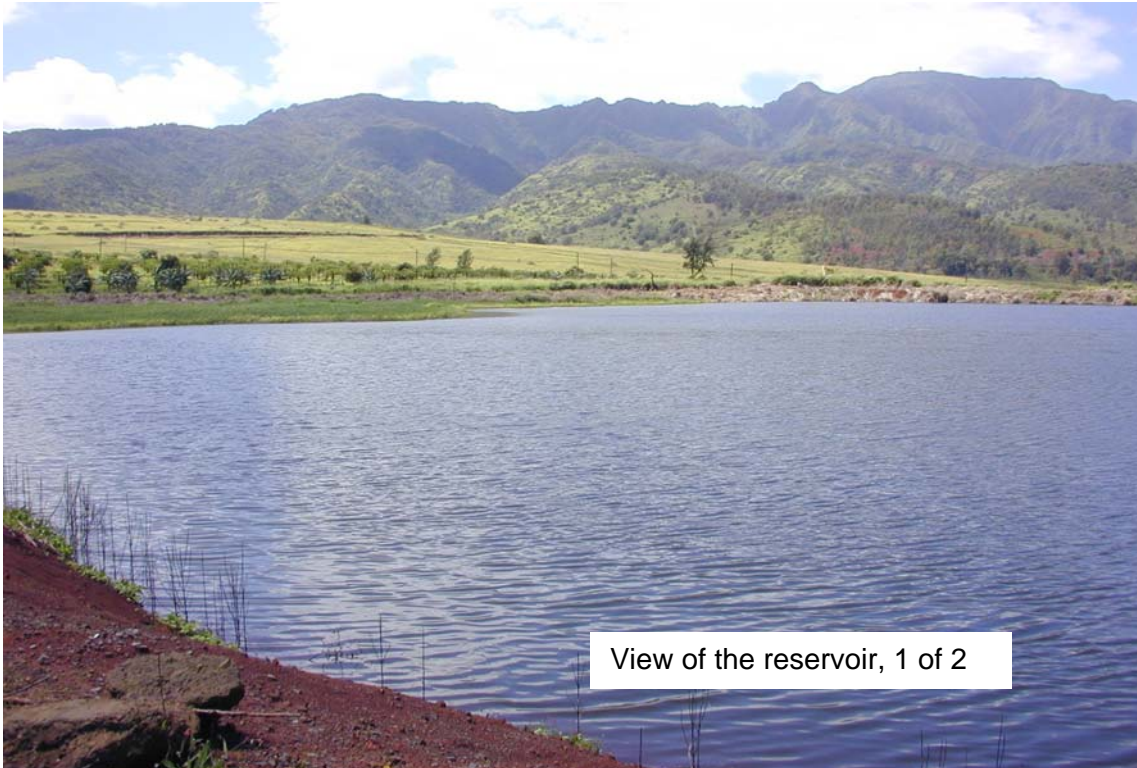
View of the reservoir, 1 of 2

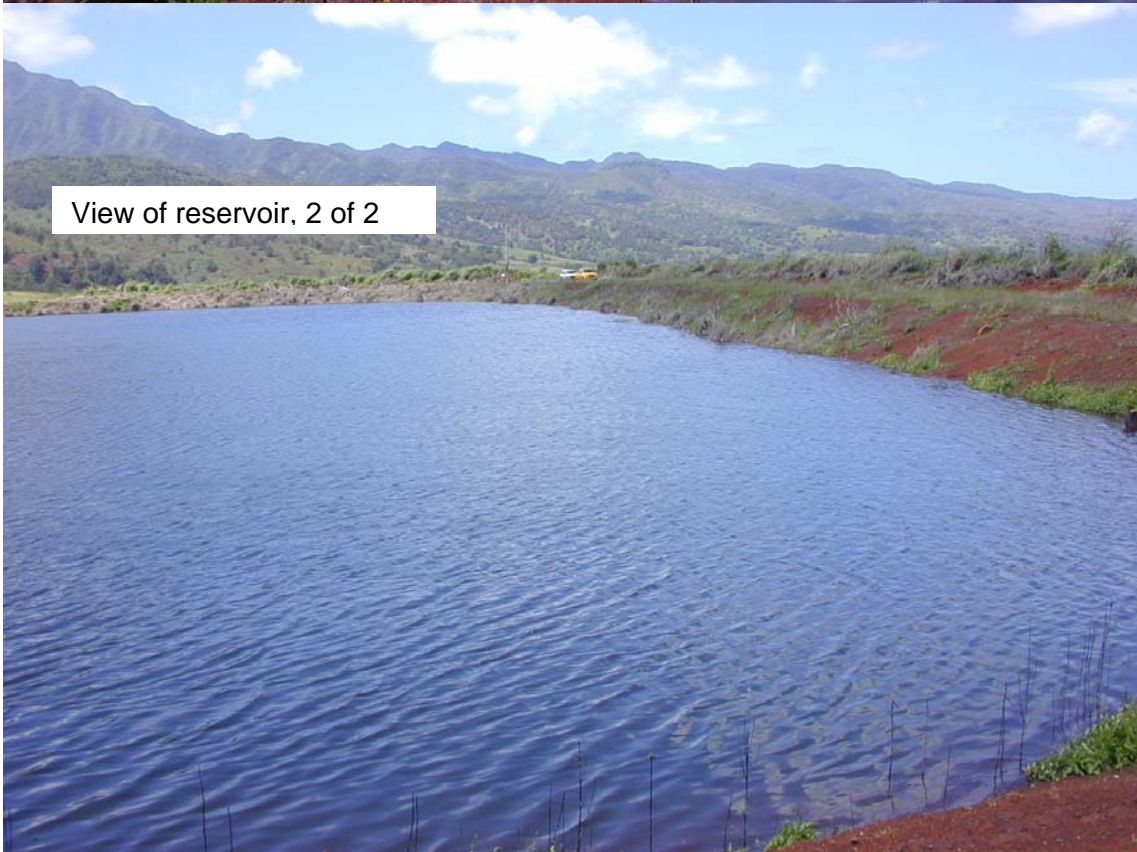
View of reservoir, 2 of 2

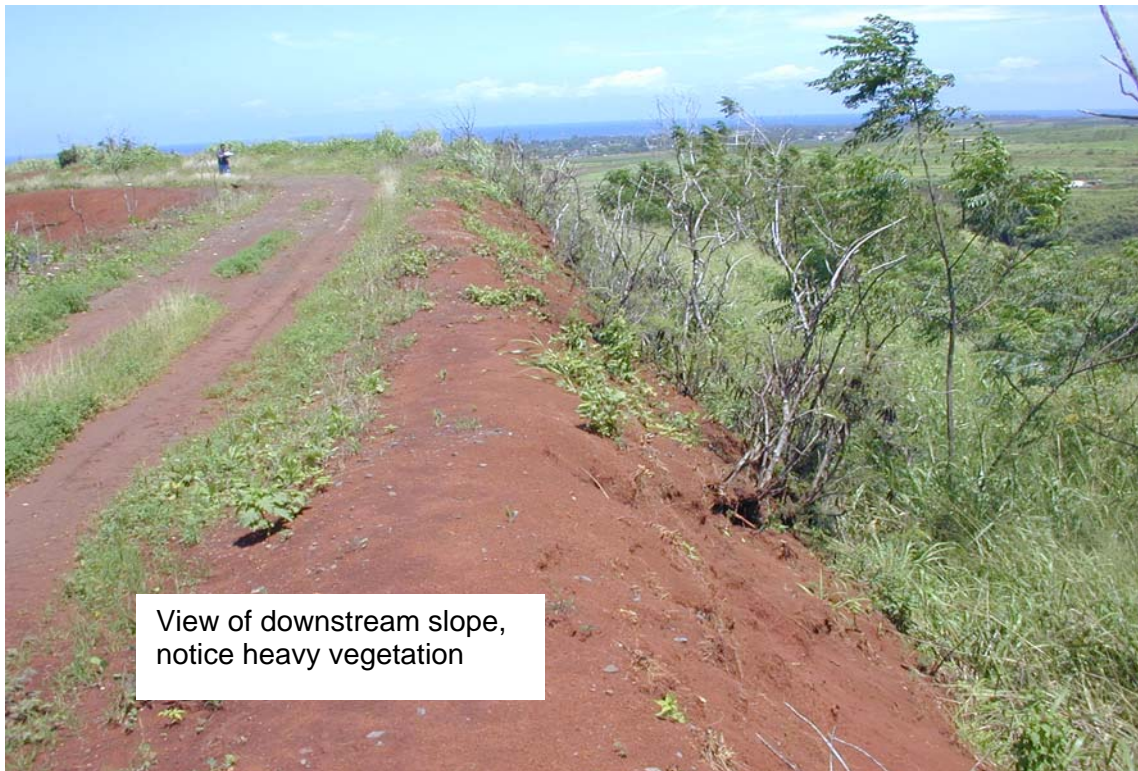
The downstream slope was in fair condition and not visible due to heavy vegetation.

Vegetation was observed on the downstream slope. The majority of the vegetation was tall grass, bushes and woody trees.

View of downstream slope,  
notice heavy vegetation

- a. The majority of the downstream slope and all of the toe was not inspected.
- b. The downstream slope appeared to be in fair to poor condition and requires corrective action.
- c. The down stream slope was not visible due to high grass and bush vegetation. Clear high vegetation and maintain low to enable easy visual inspection.

- d. Tree(s) were observed on the downstream slope. Trees have been identified as the probably cause of piping failures, and can possibly cause severe damage to the embankment if they are uprooted during a high winds. Corrective action is required to remove the tree hazards from the dam. Acceptable remedies include removal of the tree and its root structure down to a 2" diameter and reconstructing the damaged embankment section. All repair work shall be accomplished as per the requirements of licensed geotechnical or structural engineer. Routinely monitor the damaged area for signs of settlement and seepage.
- e. The slope was very steep, around a 1 to 1 slope, further study is required to verify slope stability.

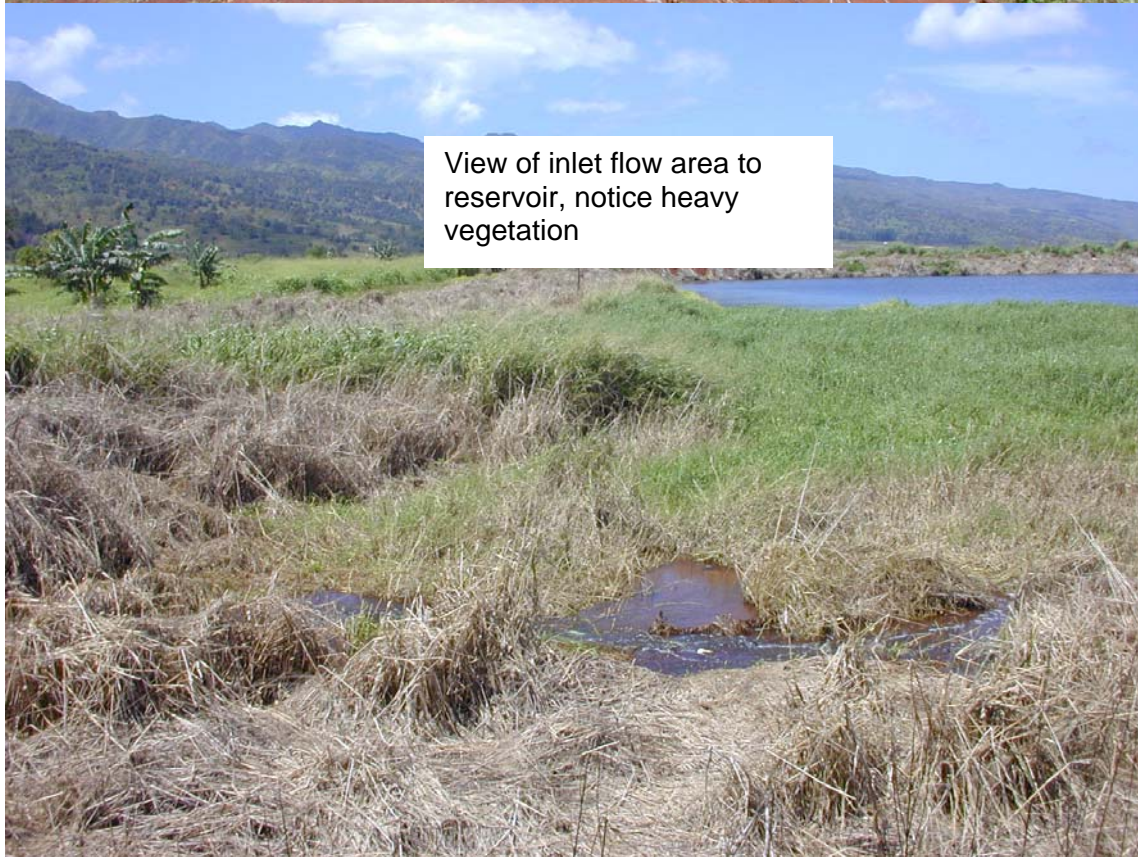
View of inlet flow area to  
reservoir, notice heavy  
vegetation
